# **INDOOR AIR QUALITY ASSESSMENT**

**Adams Town Hall  
8 Park Street  
Adams, Massachusetts**

Prepared by:  
Massachusetts Department of Public Health  
Bureau of Environmental Health  
Indoor Air Quality Program  
March 2008

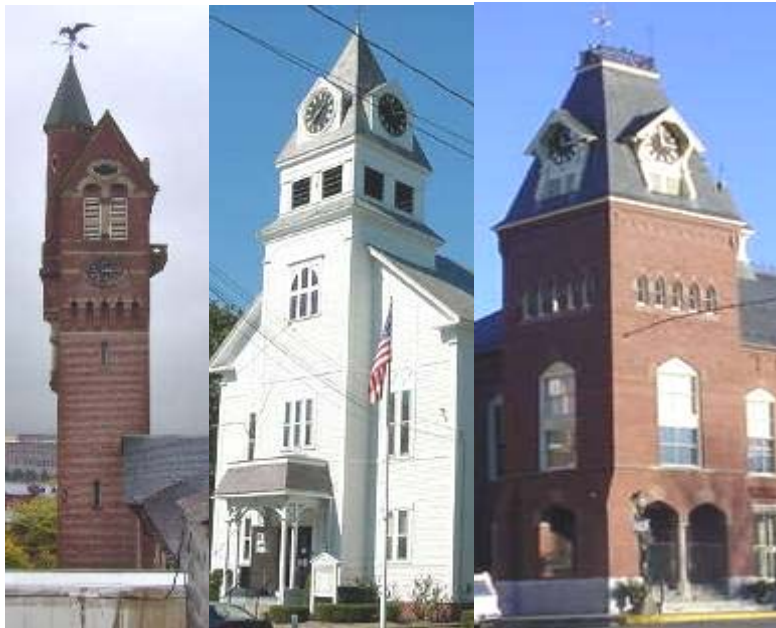
**Picture 10 Through 12**

**Example Of A Sheer Wall Clock Tower (Chicopee City Hall, Chicopee, MA), A Pyramidic  
With Sloping Roof Clock Tower (Bernardston Town Hall, Bernardston, MA) And A  
Steeple Clock Tower (Merrimac Town Hall, Merrimac, MA)**

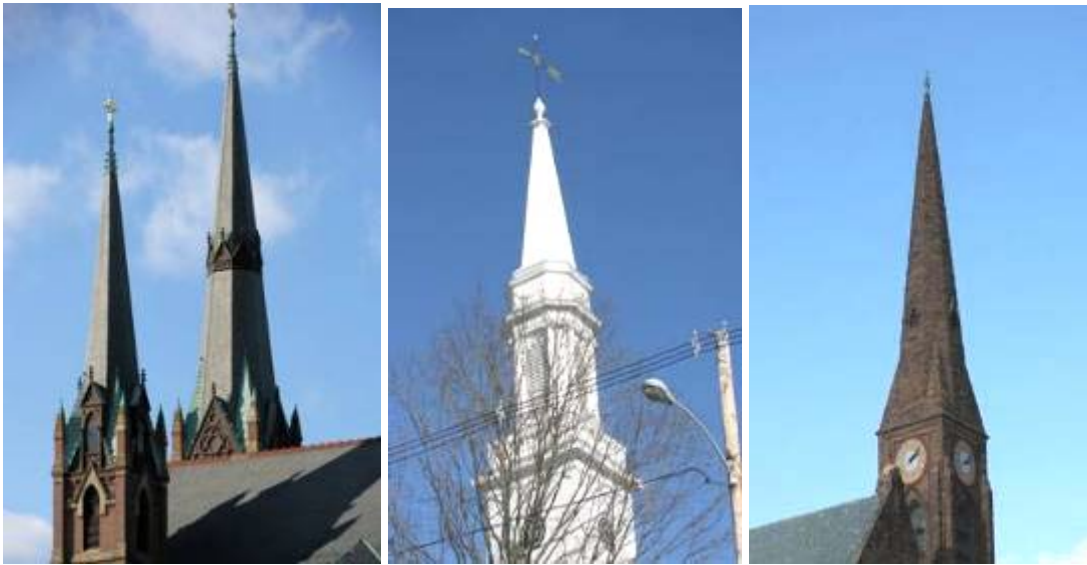
**Pictures 13 Through 15**

**Example Of Steeples (St. Mary's, Northampton, MA; Helen Hills Chapel, Northampton, MA; The First Churches, Northampton, MA)**
